Docket No. 217 – Development and Management Plan Inspection

Northeast Utilities Service Company Certificate of Environmental Compatibility and Public Need for the construction of a 345-kV electric transmission line and reconstruction of an existing 115-kV electric transmission line between Connecticut Light and Power Company's Plumtree Substation in Bethel, through the towns of Redding, Weston, and Wilton, and to the Norwalk Substation in Norwalk, Connecticut.

Date: October 4, 2006

Location: 345kV XLPE Component

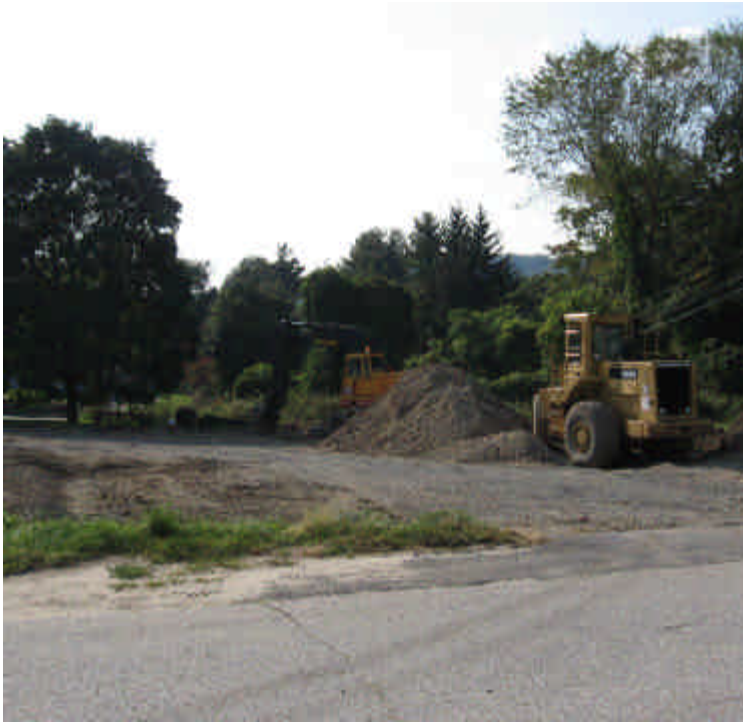
345kV XLPE: Photo on the left shows topsoil being graded out at the demobilized contractor yard in the Bethel Ed Park. Photo on the right shows the vault 5 area with well established grass cover and recently landscaped trees. 10/04/06

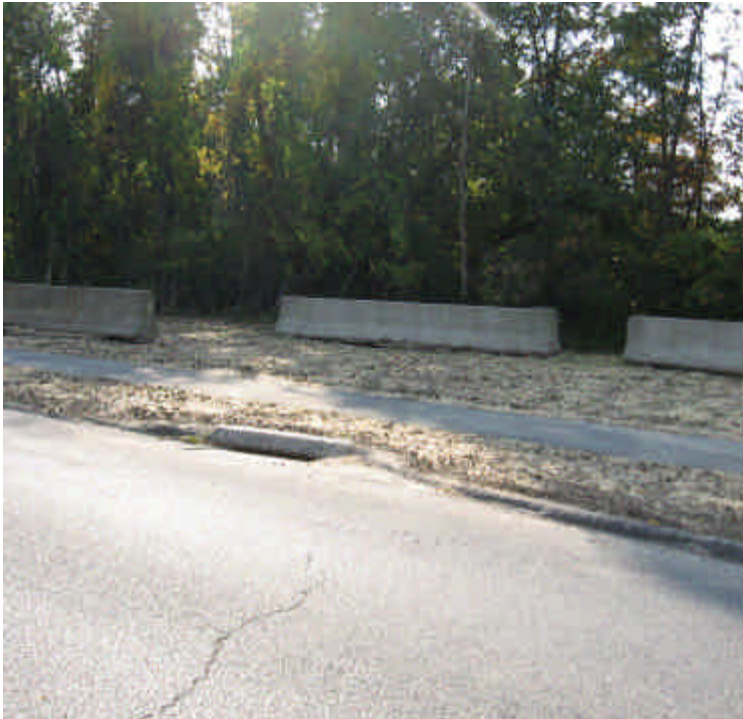
Photo on the left shows good restoration efforts (seed and mulch) in vault access areas. Photo on the right shows the jacking pit side at the jack & bore following restoration. Grass cover is establishing well and the erosion control matting remains in good shape. 10/04/06

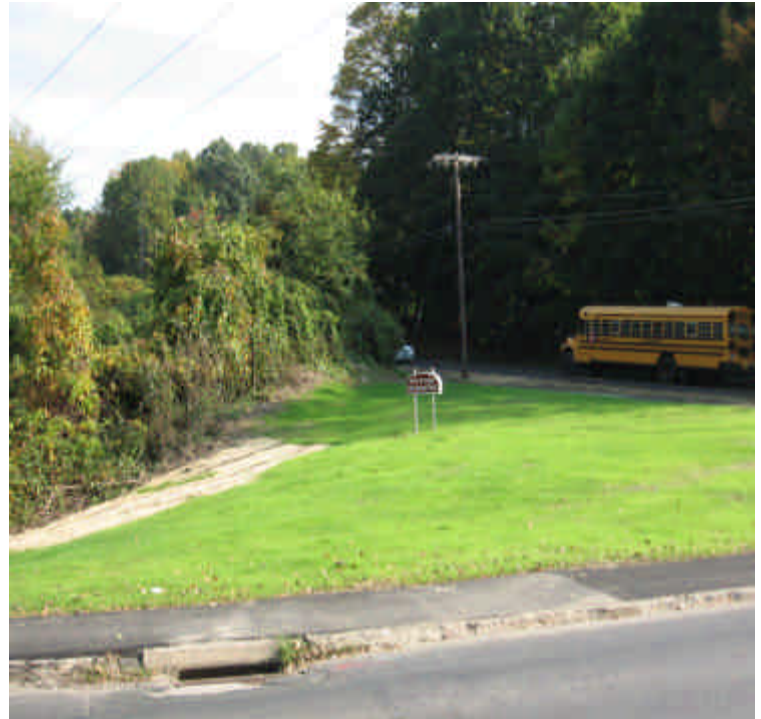
Areas of Inspection	Observation	Recommended Action	Corrective Action
Erosion and Sediment Controls (includes inspection within 24 hours of a storm event)	<ul style="list-style-type: none"> - The restored jack & bore area had good grass cover. The erosion control matting remains in good shape. 10/04/06 - The area surrounding vault 2A&B has been restored and mulched with hay. 9/29-10/04/06 -The erosion control blankets remained in place along the streambank. Vegetation remains sparse along the banks. 9/13-10/04/06 - The lawn area along the ball park access continues to have good grass cover and silt fence is in good shape. 10/04/06 - Vault 5 (in residential lawn) is stabilized with well established grass cover and was landscaped. 10/4/06 	<ul style="list-style-type: none"> -Continue to monitor for final stabilization but the area is in very good shape. 10/04/06 -Continue to monitor for successful vegetative growth and final stabilization. 10/04/06 -Continue to monitor until vegetation has established. 8/16-9/29/06 Consider adding more grass seed along the bank to get some cover. Fall seeding should generally be completed by Oct 15. 9/13-10/04/06 - Grass cover has quickly established. Silt fence could be removed when feasible. 10/04/06 - This area appears to be stabilized. 10/04/06 	<ul style="list-style-type: none"> -Grass growth continues. -The area was restored. -May need attention before the end of the growing season. -N/A - Grass cover is established and trees were planted.

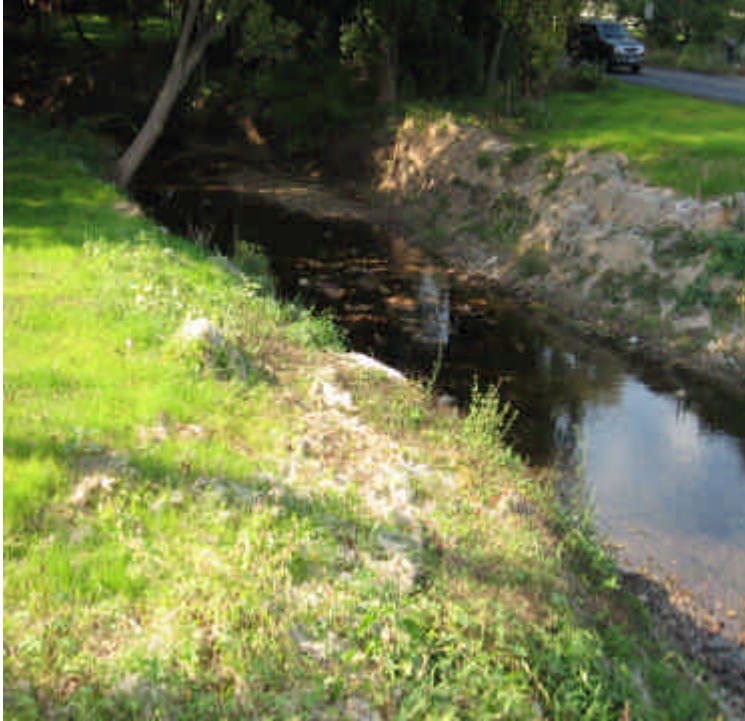
Inland Wetland and Watercourse encroachment and mitigation	<ul style="list-style-type: none"> -The banks of East Swamp Brook remain in good shape but could use additional vegetation. 9/7-10/04/06 	<ul style="list-style-type: none"> -Continue to monitor until final stabilization and consider adding grass seed for cover. 9/7-10/04/06 	<ul style="list-style-type: none"> May need attention prior to the end of the growing season
State species of concern, threatened and endangered species	<ul style="list-style-type: none"> -The D&M plan and clearance letter states that state-listed species are not located in this work area however, -The wood turtle was noted at Plumtree Substation during the 5/25/06 inspection. 	<ul style="list-style-type: none"> - N/A -345kV XLPE crews should also be performing daily walkthroughs before moving equipment if working in this vault.. 4/26-10/04/06 	<ul style="list-style-type: none"> -N/A - N/A

Photo on the left shows the stream bank with patchy vegetation returning. Additional seed or cover may be necessary prior to the end of the growing season. Oct 15 is generally recommended as the end of fall seeding. Photo on the right shows the restored area in the ball-park with increasing grass cover. 10/04/06.

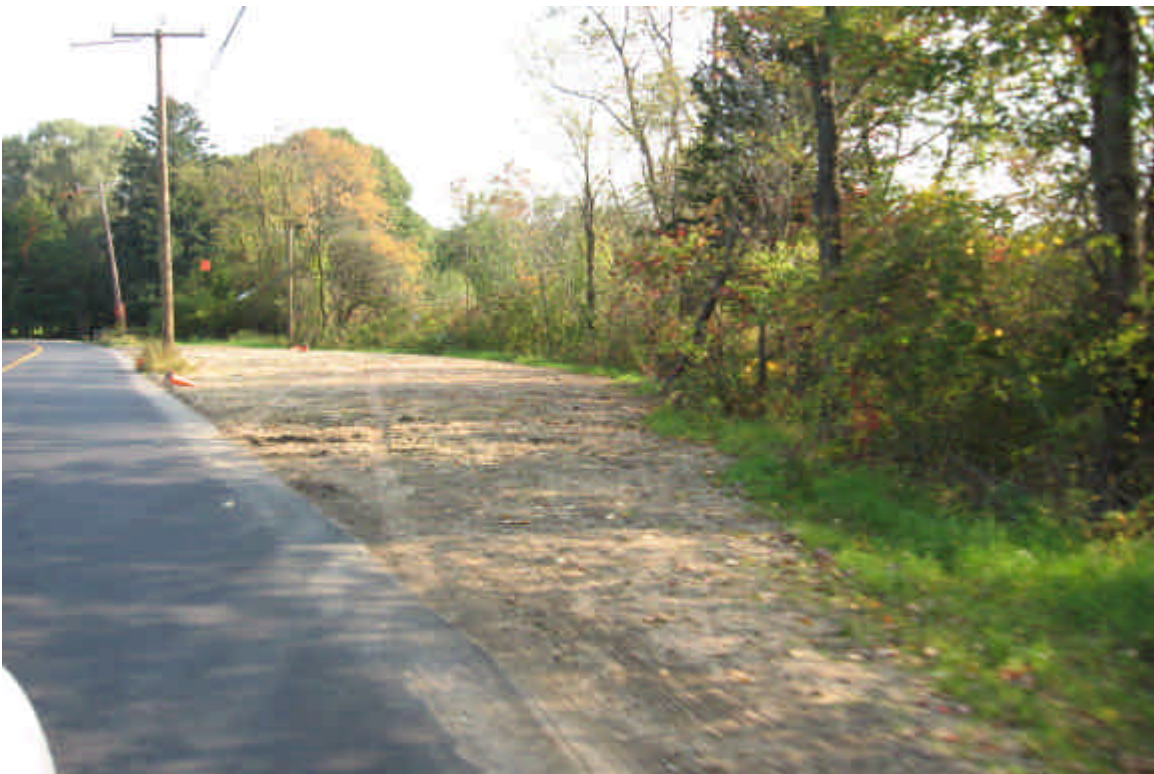
Photo shows restoration efforts at vault 2. Little grass growth was noted here. 10/04/06
